*Preliminary Report on
Bluff Rd.*

PRELIMINARY REPORT
GROUNDWATER AND SURFACE WATER INVESTIGATION
SOUTH CAROLINA RECYCLING AND DISPOSAL, INC.
BLUFF ROAD SITE
COLUMBIA, SOUTH CAROLINA
April 24, 1980

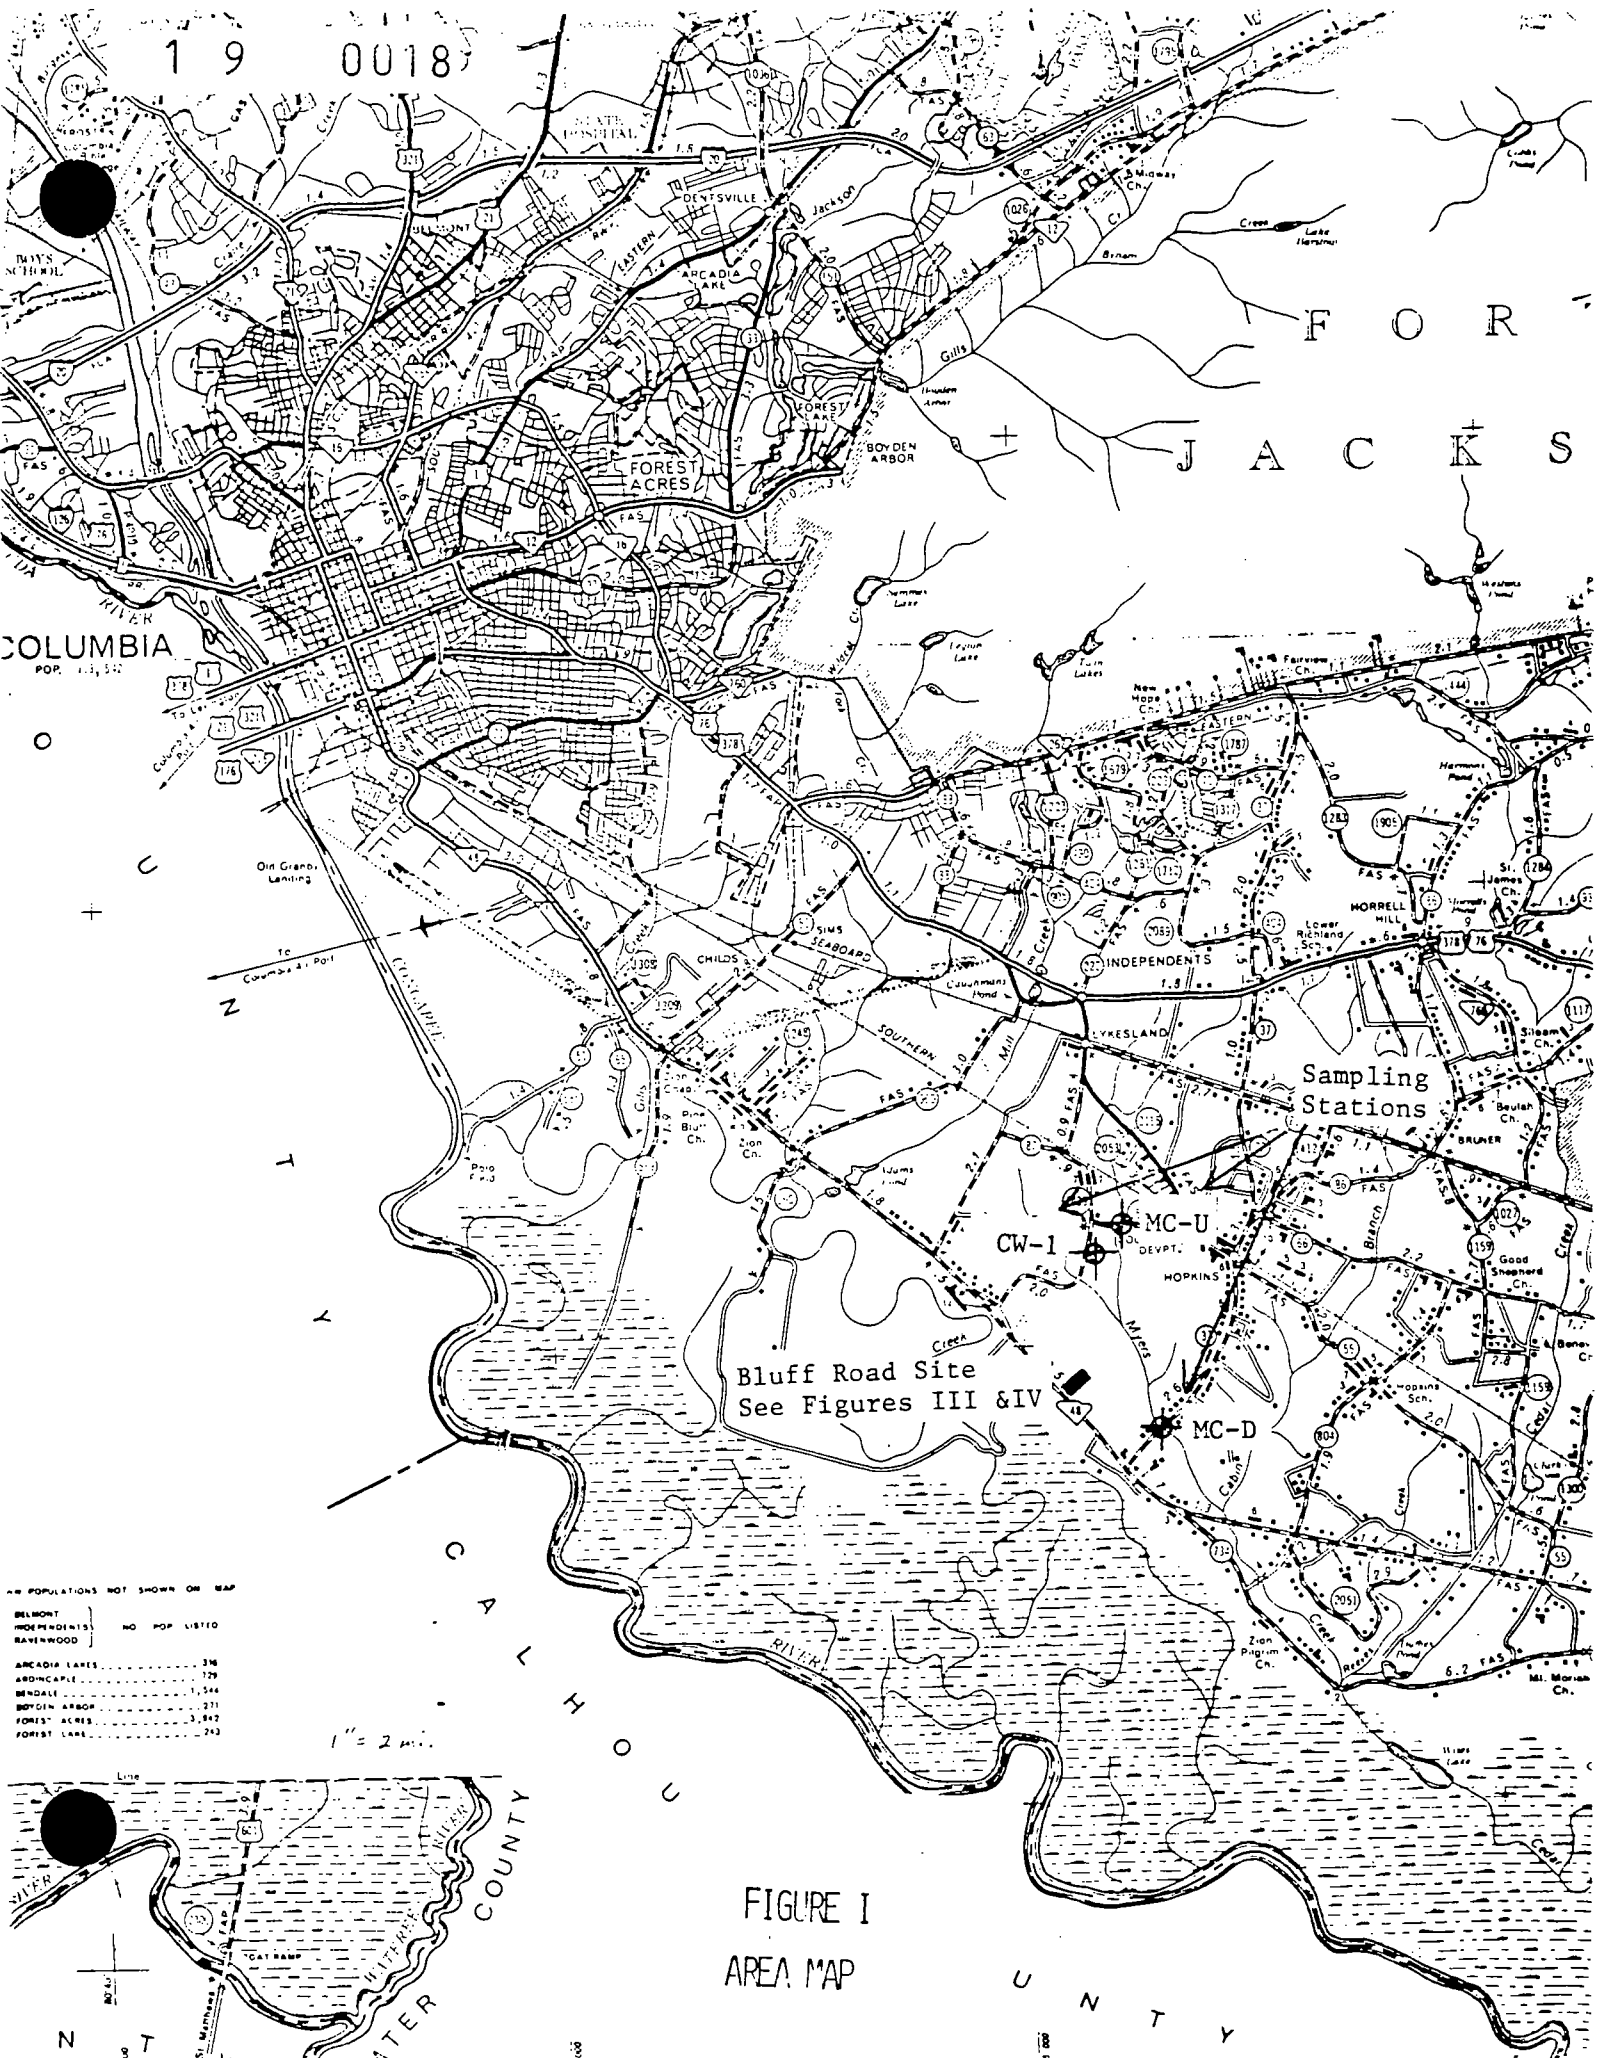
FIGURE I
AREA MAP

Figure I is an area map showing the location of the Bluff Road site and three of the sampling stations. Locations of the remainder of the sampling stations are shown on Figures III and IV. All sampling stations and types of samples collected at each are described on Table I.

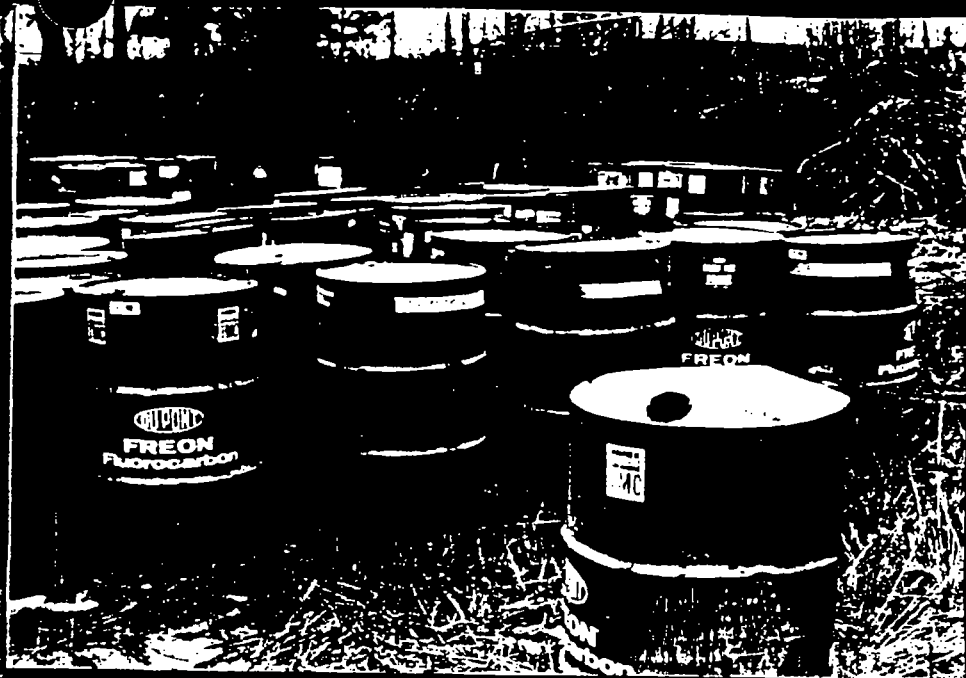
- Drums of waste chemicals (acetone, ethyl alcohol, freon, and perchloroethylene) and empty one gallon jugs (formerly containing reagent grade trichloroethylene) were stored on the highway right-of-way between Bluff Road and the fence along the front of the facility (photographs 1 and 2). Information concerning the drum contents and the former contents of the jugs was noted from labels and confirmed by Mr. James McClure, the site operator.

No. 1-Drums stored along the highway right-of-way between Bluff Road and the fence at South Carolina Recycling and Disposal, Inc. Drums in the foreground reportedly contain waste freon. These in the left background reportedl contain waste acetone and waste ethyl alcohol while those in the right background reportedly contain perchlor-ethylene.

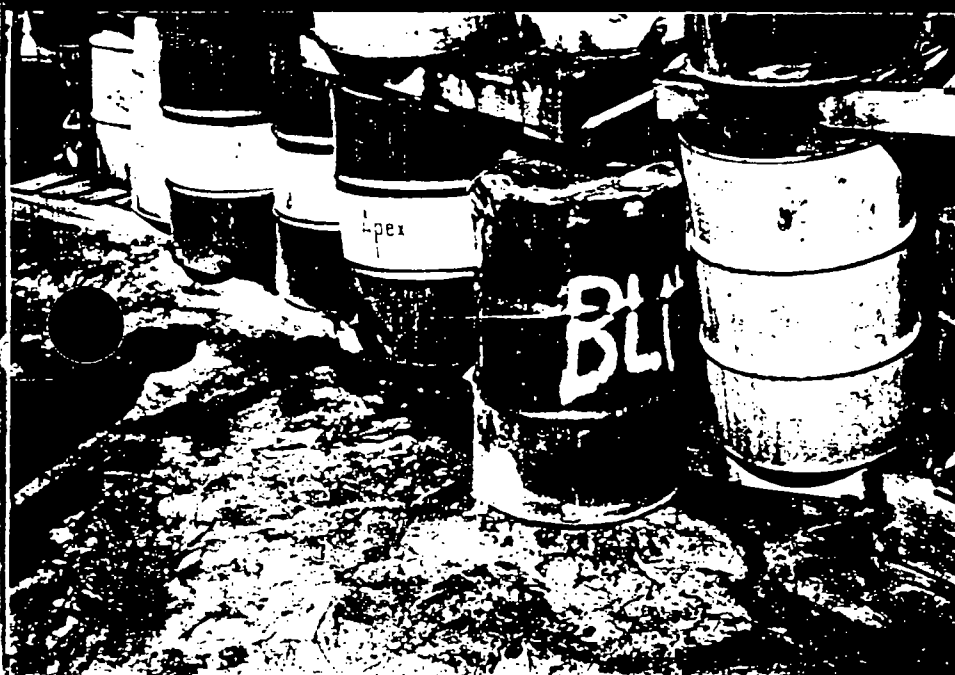
- There were numerous examples of spillage and/or leaking drums in the drum storage area (photographs 3, 4, and 5).
- Chemical spillages exist in direct contact with water pooled in the old filled lagoon (photographs 6 and 7).

No. 4-Leaking drums near sampling site SCR-3.

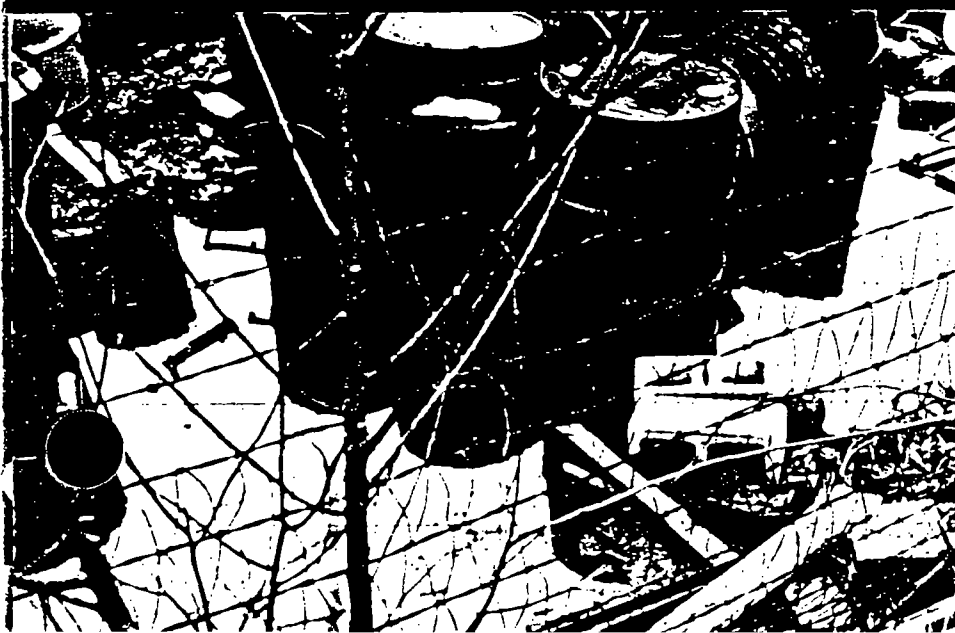
No. 5-Pooled water in drum storage area near fence between South Carolina Recycling and Disposal, Inc. and Campbell and Sons Garage (sampling site SCR-2).

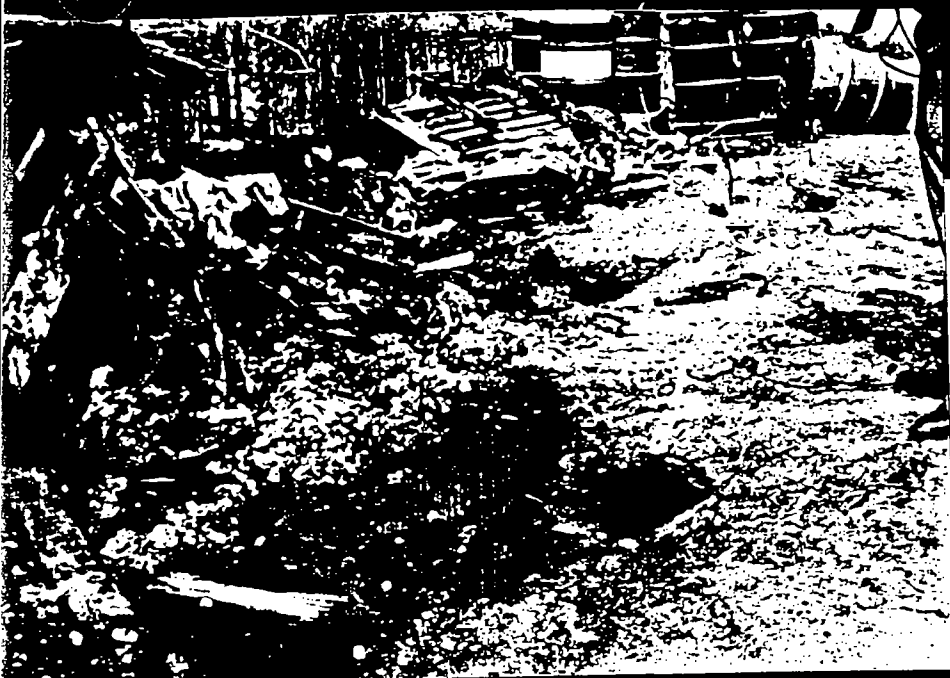
- Drums of zirconium tetrachloride stored near the lagoons have disintegrated. Part of this material has been re-drummed, but active zirconium tetrachloride is still exposed on the ground surface (photographs 6 and 7). Upon contact with water, this compound fumes, emitting HCl gas. On March 18, 1980, after heavy rains the previous night, the exposed material was fuming.

No. 6-Zirconium tetrachloride (blackish material) mixed with disintegrated drums and other debris at the edge of a pooled area in an old filled lagoon at the northern corner of facility (sampling site SCR-4). Re-drummed zirconium tetrachloride can be seen in the background.

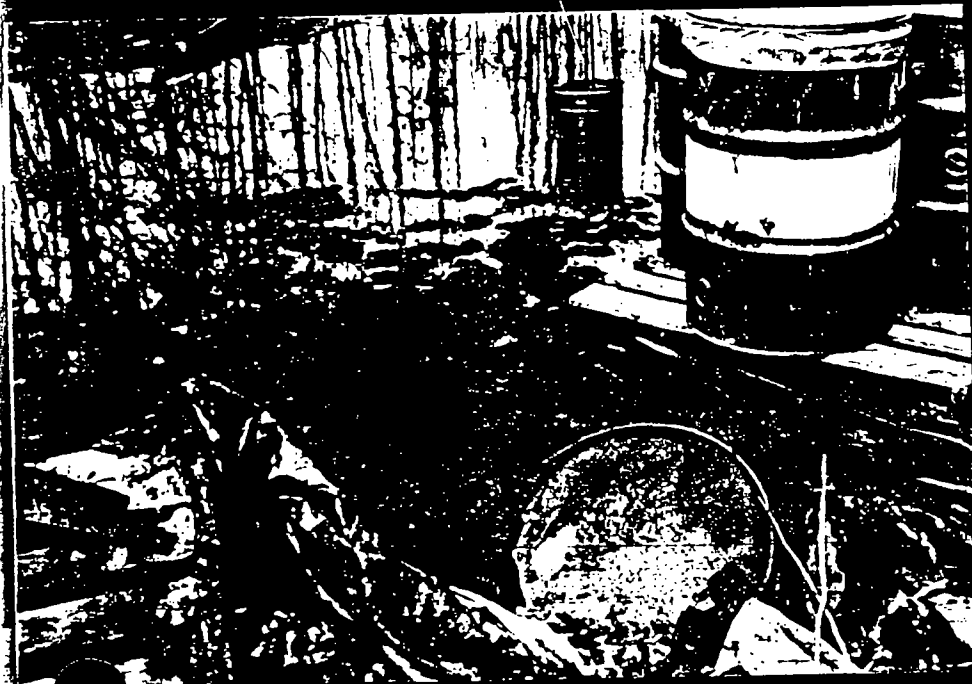
No. 7-Close-up of black, oily sludge shown in background of above photograph.

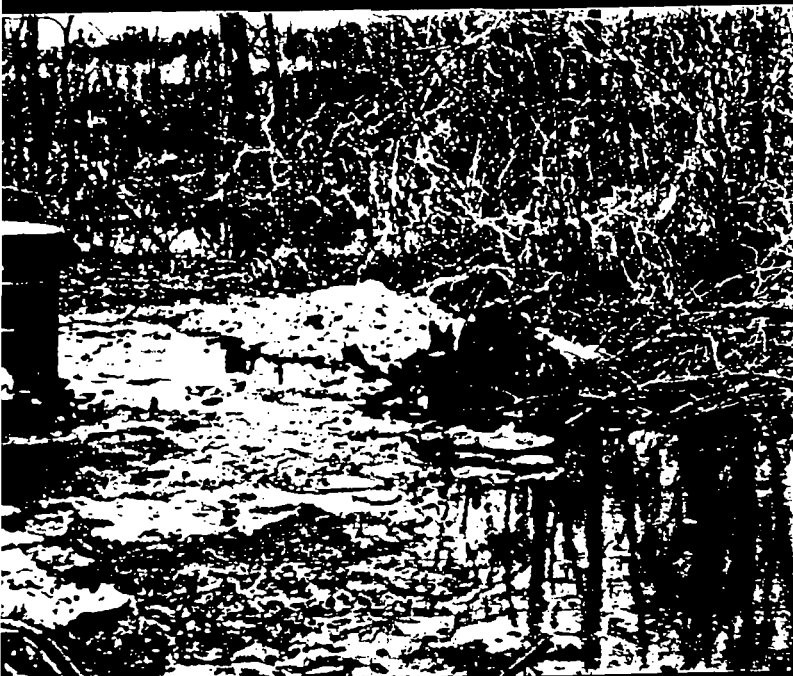
- Another point of potential runoff exists which could overflow after torrential rains (photograph 9). If dikes are built to prevent the runoff described in the above item, torrential rains would cause runoff at this point.

No. 9-Point of potential runoff from north western corner of pooled area shown in above photograph. Part of the swamp-water drainage collector ditch system can be seen in the background (sampling site RO-1).
